Richard Winter, DDS

Ariel S. Winter

Ortho-Aesthetics: One Solution to External Resorption

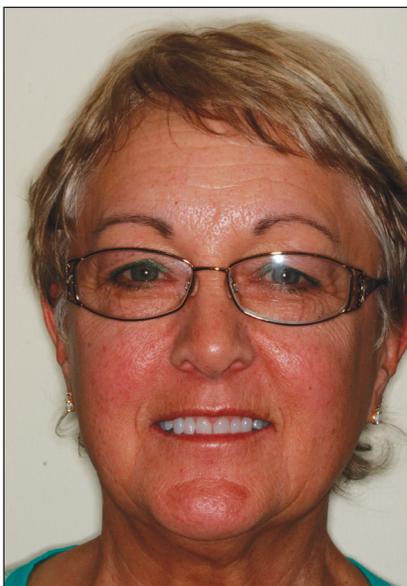
Figure 1. A full-face, preoperative photo of the patient (Class II, Division 2).

A 56-year-old woman presented with a Class II, Division 2, orthodontic classification. She had diastemas distal to her canines and a retroclined anterior maxillary segment (Figure 1). She had been bleaching weekly for more than 20 years. She reported feeling a ledge on the lingual surfaces of her maxillary anterior teeth, and then one day the ledge was gone and she felt “something weird” at the gumline. The etiology of her resorption could have been due to the long-term bleaching activity, as she reported no history of trauma, orthodontics, or any other inci-

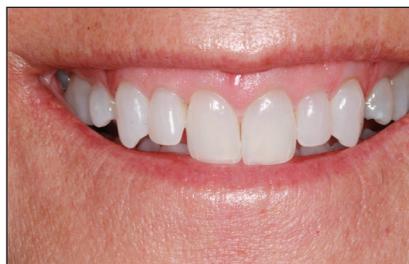
Figure 2. The pre-op retracted view.

She presented with an external resorptive lesion on the lingual of tooth No. 9, which was assessed as having a fair-to-poor long-term prognosis (see Inset on page 108). A work-up was done to assess her available bone for an implant, abutment, and crown restoration. The patient’s retroclined incisors—coupled with a thin gingival biotype and gummy smile, along with a near translucent enamel shade—necessitated evaluating orthodontics with (or without) a cosmetic rehabilitation of the anterior teeth to restore her teeth and smile to a more ideal level of aesthetics while protecting a severely compromised tooth No. 9 (Figures 2 to 5).

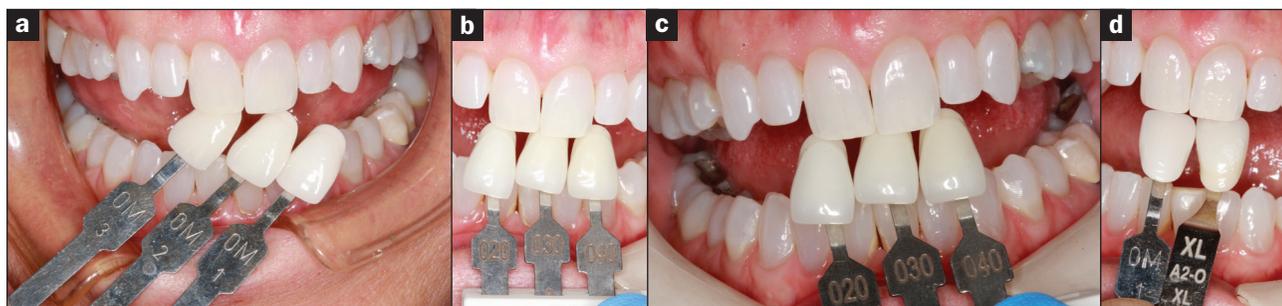
Figures 6a to 6d. Shade tab photos for the lab.

Implant replacement of tooth No. 9, with the resulting abutment/implant angle due to a Class II, Division 2 orthodontic classification, would have made implant placement and prosthetic rehabilitation difficult. Furthermore, if implant placement was to be considered, the thin gingival biotype, quality and quantity of bone, and high smile line would have made this aesthetic rehabilitation challenging. Lastly, the patient’s frequent bleaching and the difficulty in shade matching made the comprehensive aesthetic rehabilitation a more predictable solution to these myriad problems. The use of multiple shade guides could not approximate a close match if a one-tooth solution was chosen (Figure 6).

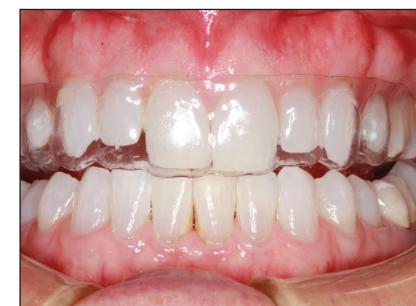
Figure 7. A clear pull-down matrix was made from the diagnostic wax-up and is shown here over the teeth.

After a facebow transfer and alginate impressions were taken, a diagnostic wax-up (Glidewell Laboratories) was fabricated. A clear pull-down matrix was made over a stone model of the wax-up and was used to assess the teeth and to create a preparation guide prior to initial tooth reduction (Figure 7). This clear template was filled with bis-acryl temporary material (Integrity Multi-Cure

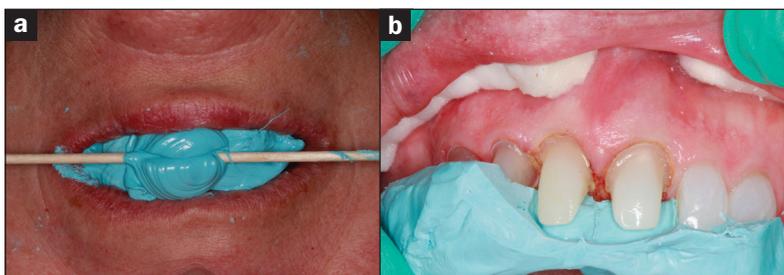
Figure 8a. The stick bite (Blu-Mousse [Parkell]).

Figure 8b. The sequential bite registration (Blu-Mousse).

dures were repeated on the patient's left side. Next, teeth Nos. 8 and 9 were prepared and (again) the bite was relined so that there was a segmental bite as well as an untouched stick-bite for the lab team to use for verification of the bite registration (Figure 8). The dentin shades were then captured with photos that included the shade guide tabs (Figure 9). Note the respect that has been paid to the tissues by careful retraction via the use of gingival retraction instruments. Not only were gingival zeniths preserved, but the

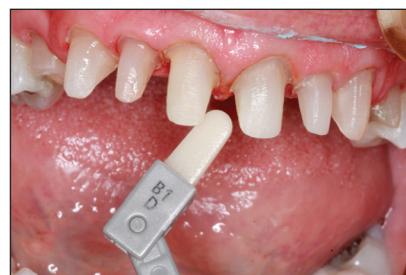
Figure 9. The stump (stump) shade of preparations.

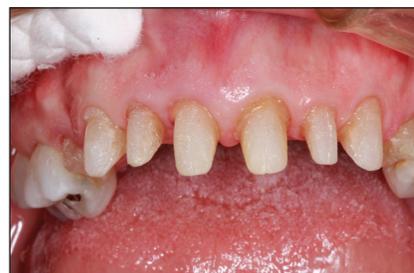
Figure 12. Healed tissue, after one month in the provisionals.

The ability to perform predictable aesthetic rehabilitation requires that the soft tissues be given time to heal and mature. Giving provisional restorations a “test drive” allows patients to evaluate aesthetics, phonetics, and function prior to seating the definitive restorations and, in addition, allows for an intraorally confirmed template for the prototypic restoration (Figure 12). This light-cured or dual-cured bis-acryl material is strong, taking on

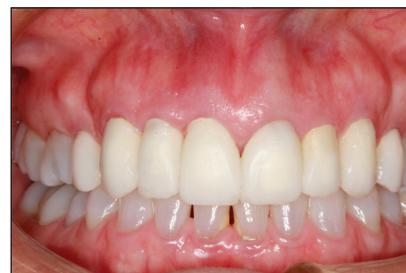
Figure 13. The provisionals, prior to staining and glazing.

a high shine once polished. Figure 13 shows the contouring of the restorations prior to glazing and polishing.

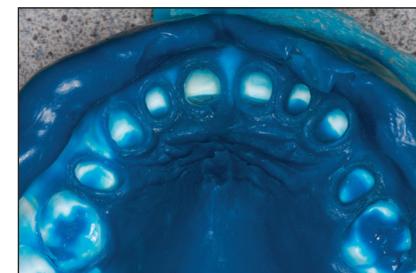
Figure 14. A vinyl polysiloxane (VPS) impression (Aquasil Ultra Xtra [Dentsply Sirona Restorative]) was taken of the preparations.

Ultra Xtra [Dentsply Sirona Restorative]) that exhibits hydrophilicity and high tear strength, and a working time that gives the operator a full 5 minutes to carefully inject the material in a wash/tray application provided an excellent master impression (Figure 14). In addition, a stick bite, a master bite, and stump (stump) and enamel shade photos provided the dental labo-

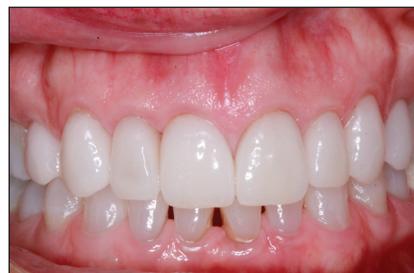
Figure 15. Lithium disilicate (IPS e.max [Ivoclar Vivadent]) crowns on the day of cementation.

Immediately after cementation, the layered lithium disilicate (IPS e.max [Ivoclar Vivadent]) restorations displayed symmetry of form and function with no bleeding and well-healed gingival tissues (Figures 15 to 18). However, since this case cannot be stated as a successful resolution of this patient's

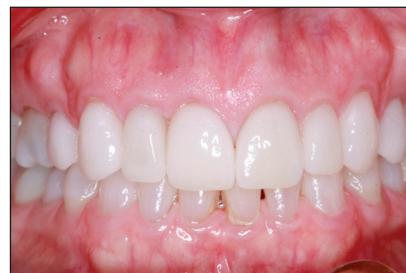
Figure 16. A 3-year postoperative photo of the lithium disilicate (IPS e.max) restorations.

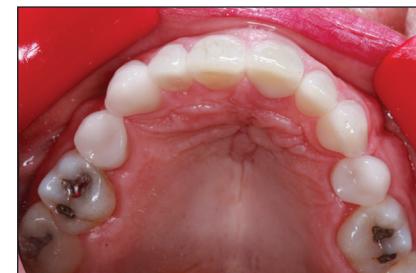
Figure 17. The occlusal view of the 3-year-old restorations.

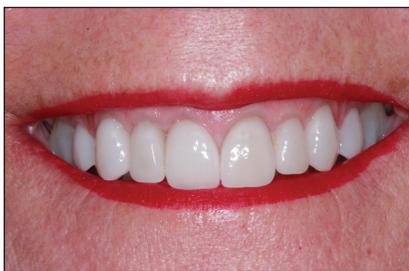
Figure 18. The smile view at 3 years post-op.

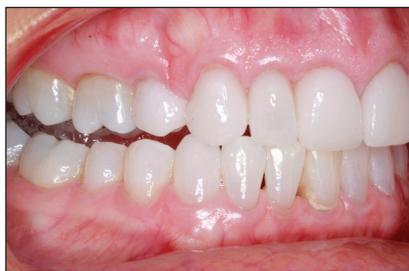
Figure 19. The canine guidance right at 3 years post-op.

problem without demonstrating longevity of the work accomplished, the 3-year postoperative photos are shared here to document the morphologic balance, bilateral canine guidance (as designed and tested in provisional restoration), and anterior guidance achieved for the patient (Figures 19 and 20). The patient's soft-tissue contours have remained stable, and the occlusal view displays normalized contours and maintenance of cuspal integrity. The patient was as pleased with the aesthetics of her rehabilitation at 3 years post-op as she was when it was first cemented (Figures 16 to 20). The periapical radiograph and CBCT, taken 3 years post-op, demonstrate the lack of spread of the ECR as well as intimate coverage by the all-ceramic (IPS e.max) crowns (Figures 21 to 22). The 3-year post-op photos shared here demonstrate the well-maintained cosmetic rehabilitation of this complex and aesthetically compromised case (Figure 23).

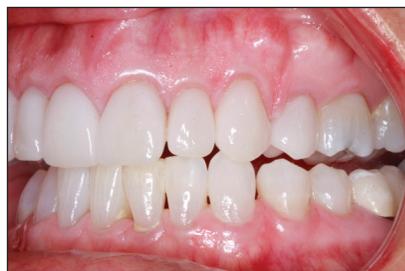
Figure 20. The canine guidance left at 3 years post-op.

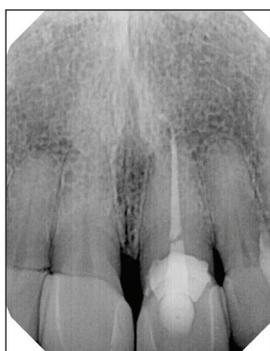
Figure 21. The 3-year post-op periapical radiograph, taken after repair of resorption and restoration.

according to Heithersay,³ penetrated close to the coronal pulp with a well-defined resorptive lesion that did not penetrate the radicular root structure (Figures 21 and 22). Heithersay³ has reported a 100% success rate in treatment of Class I and II ECR lesions and a success rate of 77.8% with Class III lesions.

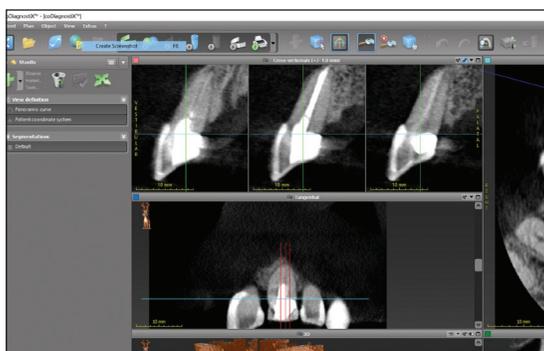
Figure 22. A CBCT showing the extent of the Class II external cervical resorption.

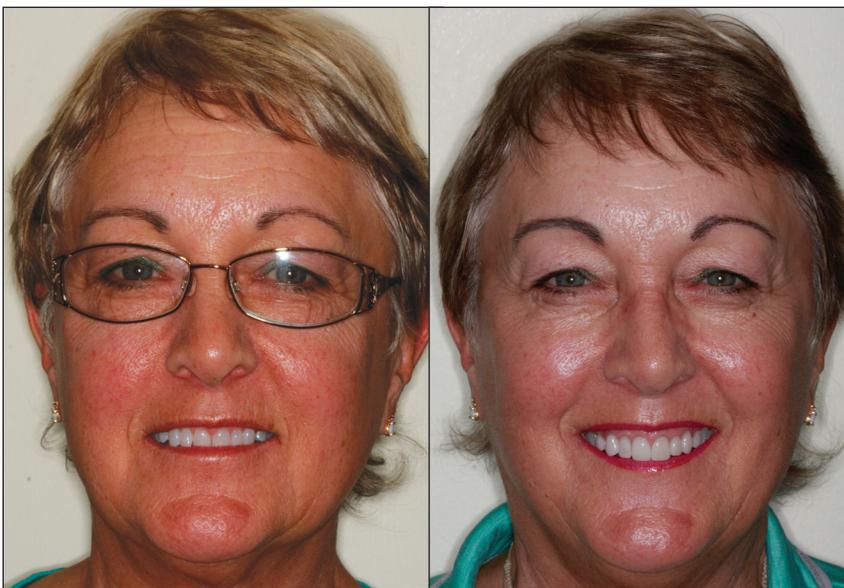
Figure 23. Pre- and post-op photos of the cosmetic rehabilitation.
